PFR19-910

MONDEO REAR SUBFRAME MOUNTING BUSH

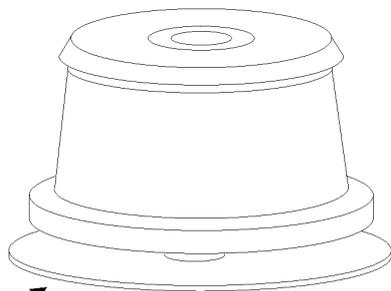
Metal securing
washer

If this has happened then the inner part of the bush will fall out quite easily. All that is then required is that the original outer sleeve (which is bonded into the subframe) be cleaned up before fitting the new bushes.

The outer metal sleeve into which the new bush is fitted will be very rusty. This must be cleaned as carefully as possible to remove all traces of rust.

Do not grease the new bush before fitting.

If the old bush has not come away from the subframe then it will need to be cut out and any rubber bonded to the sleeve will have to be removed.
